Home Inspection Report

Somewhere
Nebraska USA

Prepared for: **John Doe**

Prepared by: **Advanced Home Inspections**
540 8th Ave. P.O. Box 146
Fairmont, NE 68354
Phone: 402-266-1373
Email: advancedhi@windstrem.net

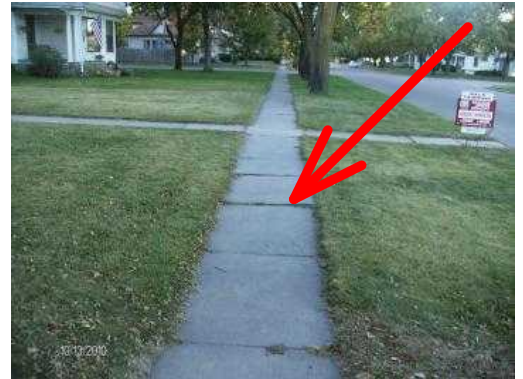
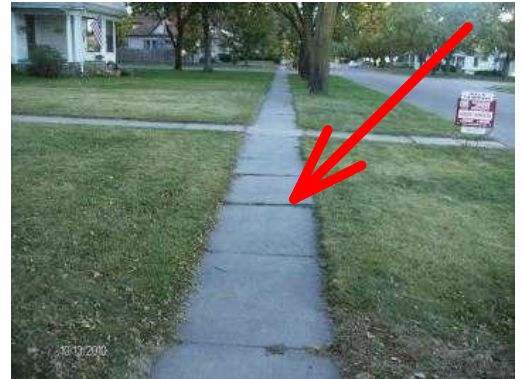
| 2. | <input type="checkbox"/> | <input type="checkbox"/> | <input type="checkbox"/> | <input type="checkbox"/> | <input checked="" type="checkbox"/> | Walks: Concrete Trip hazard |

1. Walks: Concrete Trip hazard

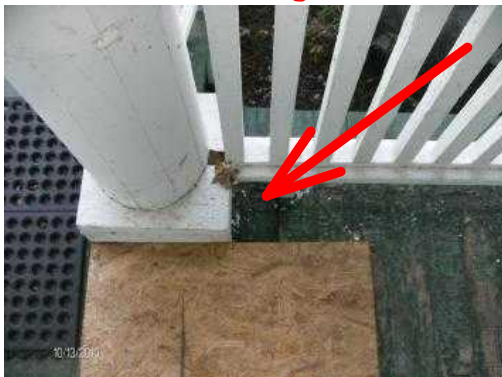
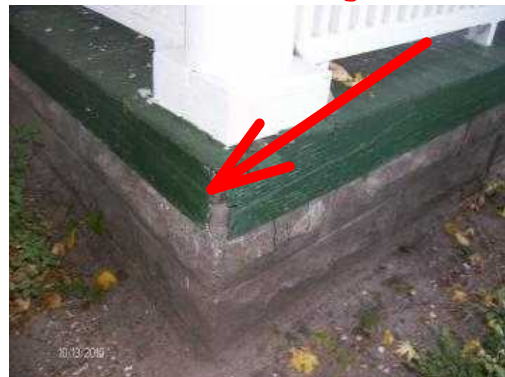
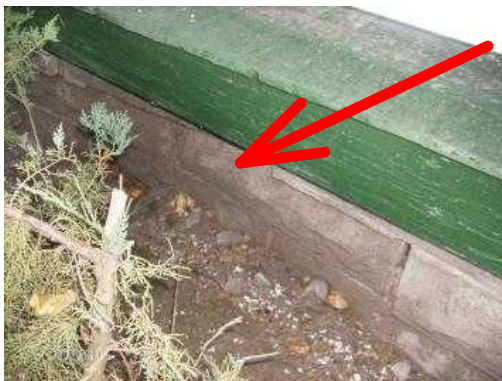
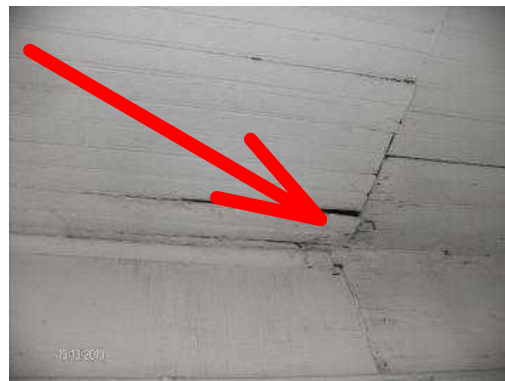
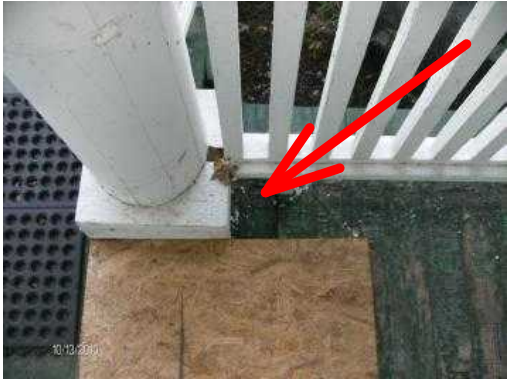
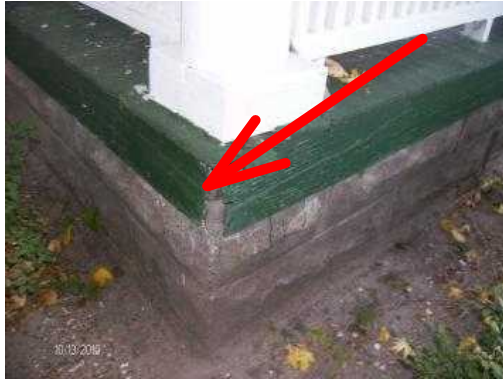
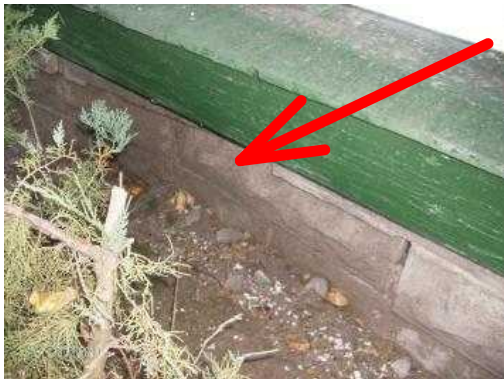
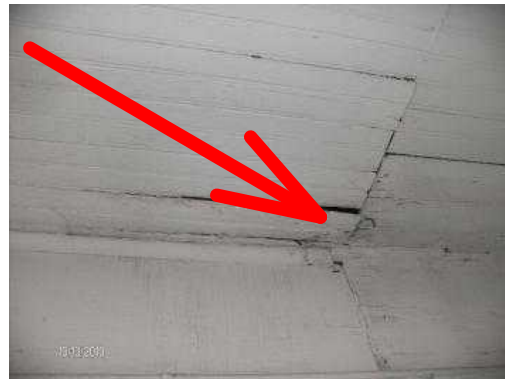
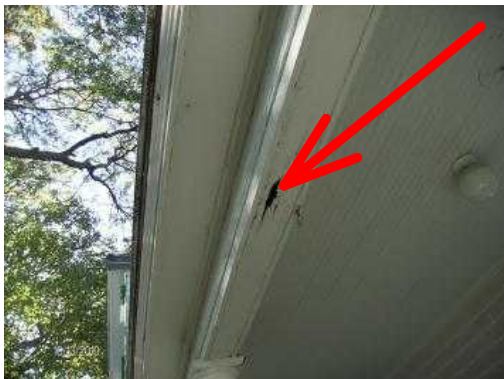
| 4. | <input type="checkbox"/> | <input checked="" type="checkbox"/> | <input type="checkbox"/> | <input type="checkbox"/> | <input type="checkbox"/> | Porch: Wood Rotting wood. Foundation has been damaged. |

1. Porch: Wood Rotting wood. Foundation has been damaged.

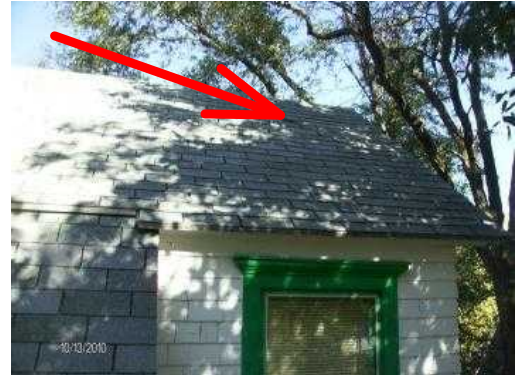
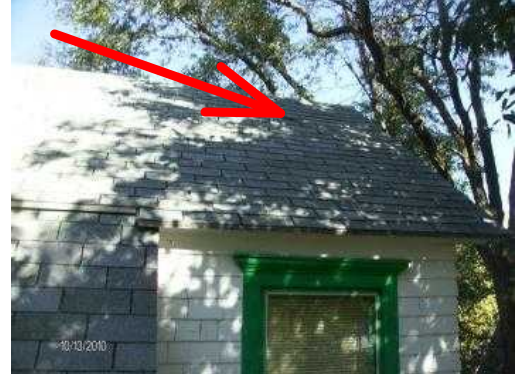
1. Method of Inspection: On roof
2. ☒ ☐ ☐ ☐ ☐ Unable to Inspect: 0
3. ☐ ☐ ☐ ☐ ☒ Material: Asphalt shingle Loose or damaged shingles

4. Main Roof Surface Material: Asphalt shingle Loose or damaged shingles

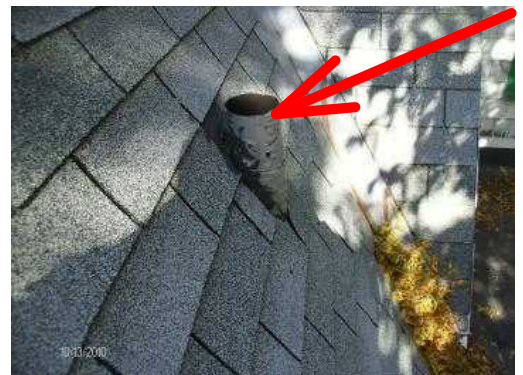
8. ☐ ☐ ☐ ☐ ☒ Plumbing Vents: Cast Iron Vents do not extend above roof enough.

5. Plumbing Vents: Cast Iron Vents do not extend above roof enough.

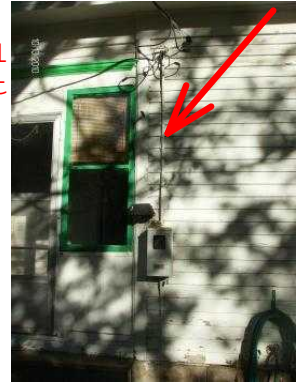
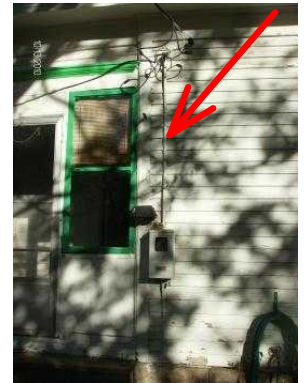
9. ☐ ☒ ☐ ☐ ☐ Electrical Mast: Mast fastened to the house A qualified contractor is recommended to evaluate. The electrical entrance cable runs down the side of the house is not enclosed in conduit.

3. Electrical Mast: Mast fastened to the house A qualified contractor is recommended to evaluate. The electrical entrance cable runs down the side of the house is not enclosed in conduit.

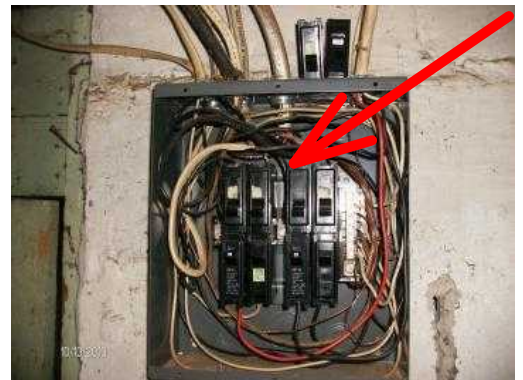
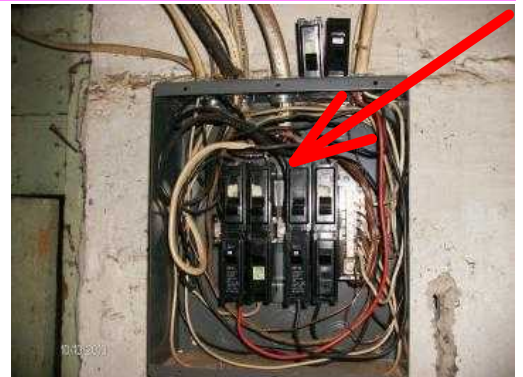
1. Service Size Amps: 100 Volts: 110-120 VAC
 2. ☒ ☐ ☐ ☐ ☐ Service: Copper
 3. ☒ ☐ ☐ ☐ ☐ 120 VAC Branch Circuits: Copper
 4. ☐ ☐ ☒ ☐ ☐ 240 VAC Branch Circuits:
 5. ☒ ☐ ☐ ☐ ☐ Conductor Type: Romex, Knob and tube
 6. ☒ ☐ ☐ ☐ ☐ Ground: Rod in ground only
- Basement Electric Panel
7. ☒ ☐ ☐ ☐ ☐ Manufacturer: Square D
 8. Maximum Capacity: 100 Amps
 9. ☐ ☒ ☐ ☐ ☐ Main Breaker Size: No single main breaker exists **No main breaker. Recommend that you get an electrician to evaluate the electrical in the whole house.**

The electrical in the house has a number of problems. The breakers are oversized for the size, there is no main breaker, the entrance cable is not enclosed in conduit and there are several wire splices in the house that are just taped and not wire nutted. It is my recommendation to get a licensed electrician to evaluate the electrical. There are no grounded circuits in the house.

4. Basement Electric Panel Main Breaker Size: No single main breaker exists No main breaker. Recommend that your get an electrician to evaluate the electrical in the whole house.

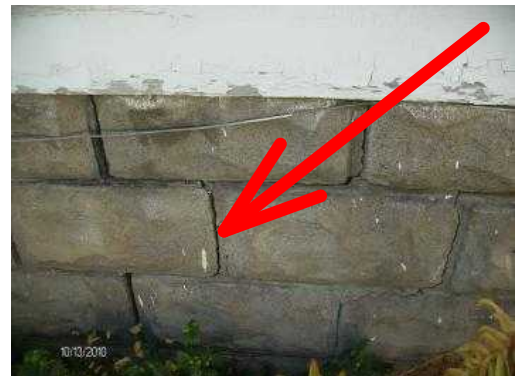
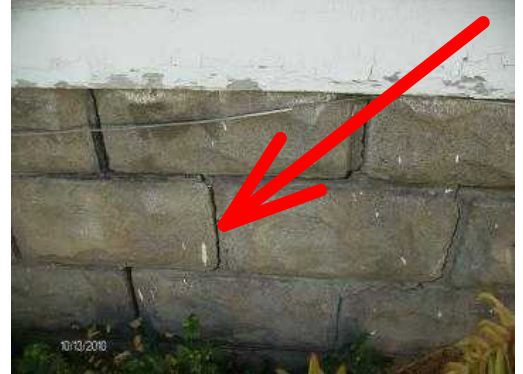
1. ☒ ☐ ☐ ☐ ☐ Structure Type: Wood frame
2. ☐ ☐ ☐ ☐ ☒ Foundation: Block **Stair step cracks**

7. Foundation: Block Stair step cracks

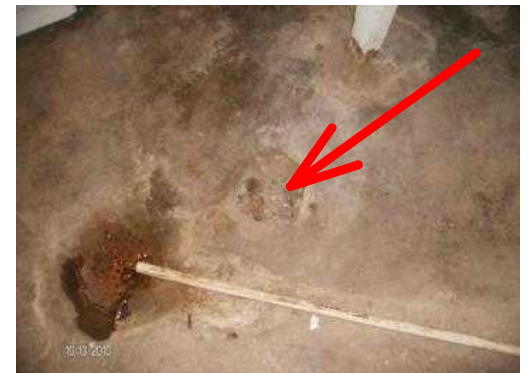
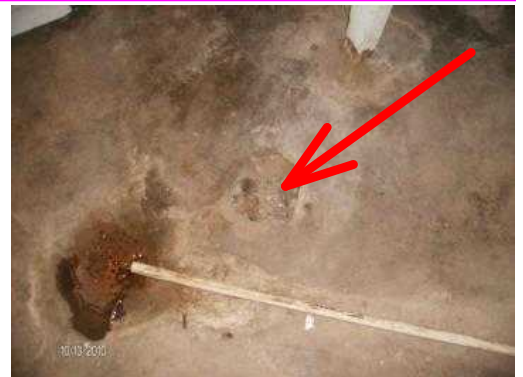
4. ☐ ☐ ☐ ☐ ☒ Floor: Poured [Hole in floor.](#)

9. Main,only partial Basement Floor: Poured Hole in floor.

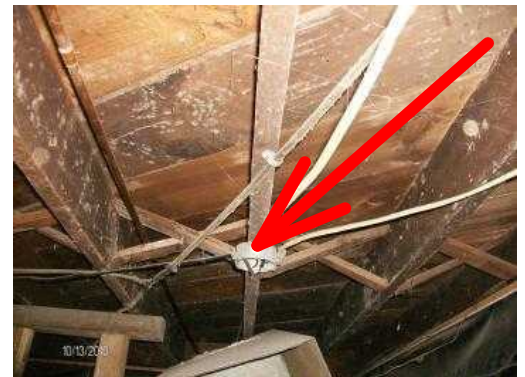
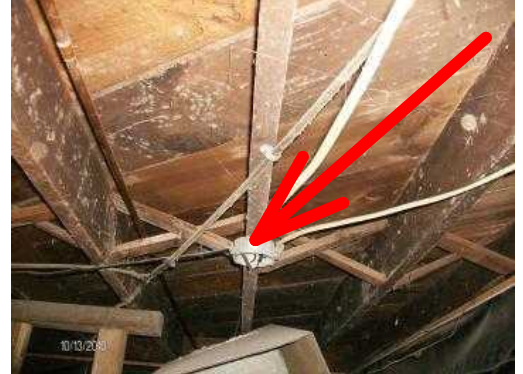
1. Method of Inspection: In the crawl space
2. ☒ ☐ ☐ ☐ ☐ Unable to Inspect: 0
3. ☒ ☐ ☐ ☐ ☐ Access: Wood door
4. ☒ ☐ ☐ ☐ ☐ Moisture Penetration: No moisture present at time of inspection
5. Moisture Location: none
6. ☒ ☐ ☐ ☐ ☐ Ventilation: None
7. ☒ ☐ ☐ ☐ ☐ Insulation: None
8. ☒ ☐ ☐ ☐ ☐ Vapor Barrier: none
9. ☐ ☒ ☐ ☐ ☐ Electrical: 110 VAC **Cover plates missing.**

6. South Crawl Space Electrical: 110 VAC Cover plates missing.

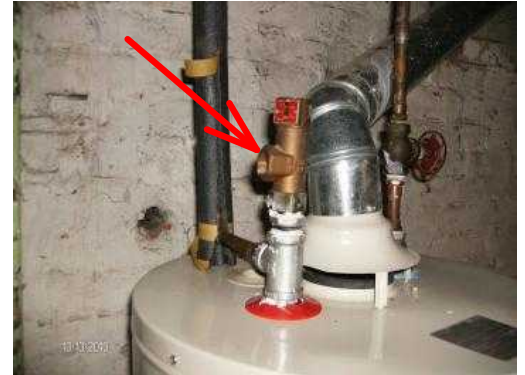
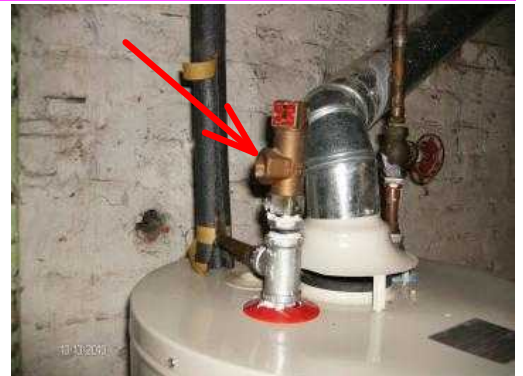
13. ☒ ☐ ☐ ☐ ☐ Flue Pipe: Single wall
 14. ☐ ☒ ☐ ☐ ☐ TPRV and Drain Tube: Brass **Missing drain tube**

8. Basement Water Heater TPRV and Drain Tube: Brass Missing drain tube

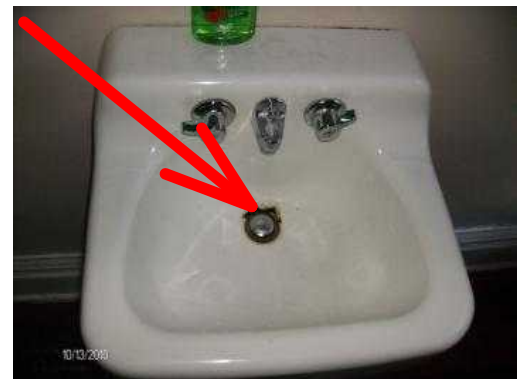
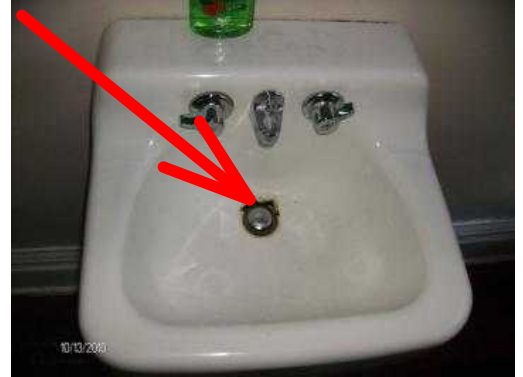
1. ☒ ☐ ☐ ☐ ☐ Ceiling: Paint
 2. ☒ ☐ ☐ ☐ ☐ Walls: Wallpaper, Paint
 3. ☒ ☐ ☐ ☐ ☐ Floor: Carpet
 4. ☒ ☐ ☐ ☐ ☐ Doors: Solid wood
 5. ☒ ☐ ☐ ☐ ☐ Windows: Wood double hung
 6. ☒ ☐ ☐ ☐ ☐ Electrical: Lights only
 7. ☐ ☒ ☐ ☐ ☐ Sink/Basin: Porcelain Sink is chipped and rusted.

9. 2nd floor main Bathroom Sink/Basin: Porcelain Sink is chipped and rusted.

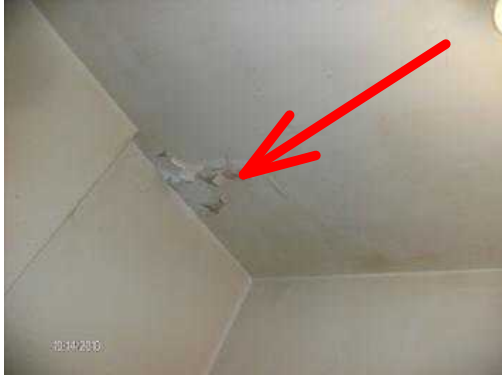
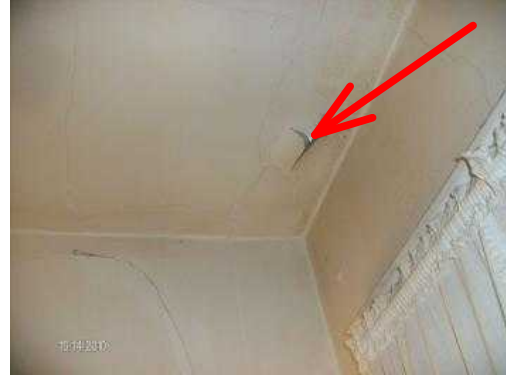
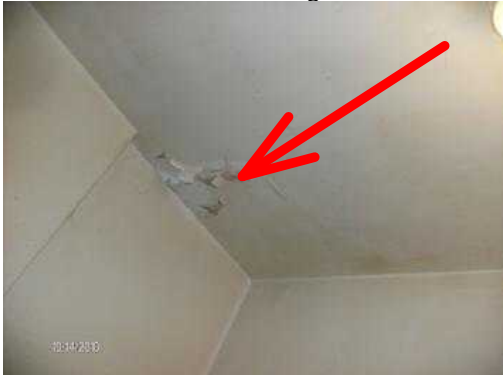
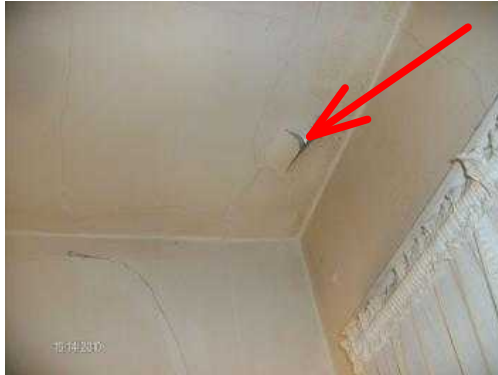
12. ☐ ☒ ☐ ☐ ☐ Ceiling: Paint **Loose or peeling paint**

10. Master Bathroom Ceiling: Paint Loose or peeling paint

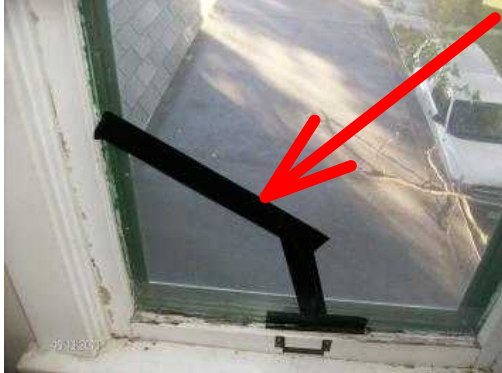
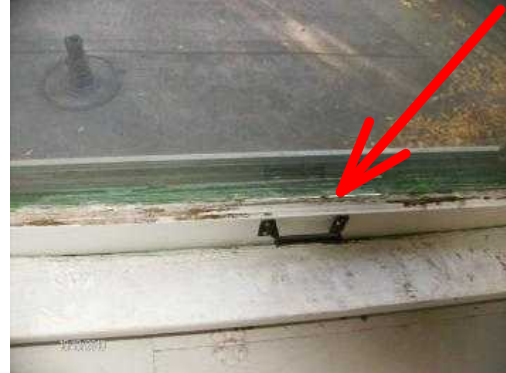
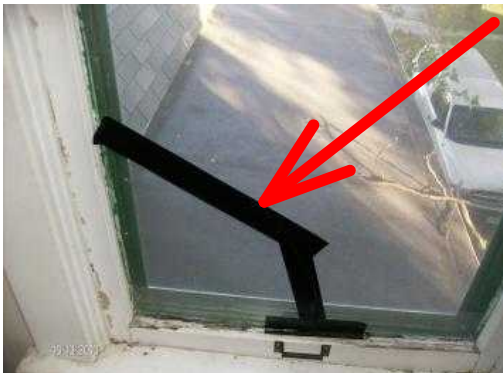
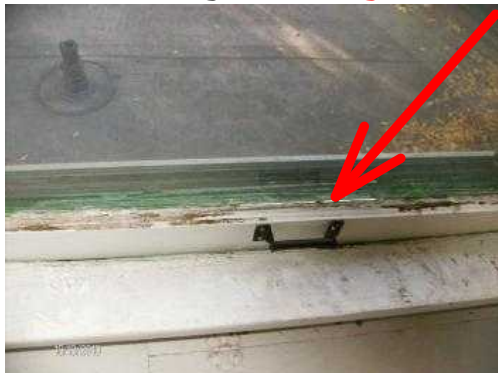
15. ☐ ☒ ☐ ☐ ☐ Windows: Wood double hung Broken glass and not glazed.

13. 2nd floor north Bedroom Smoke Detector: No smoke detector located in room. No smoke alarm in bedroom.
14. 2nd floor east Bedroom Windows: Wood double hung Broken glass and not glazed.

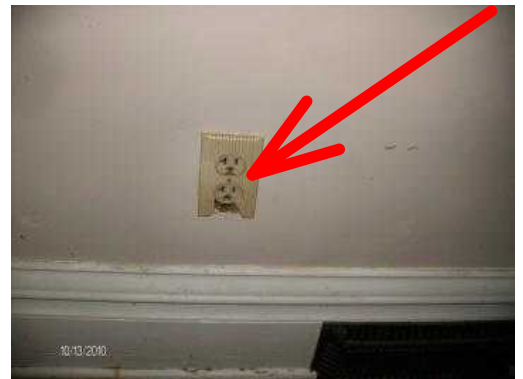
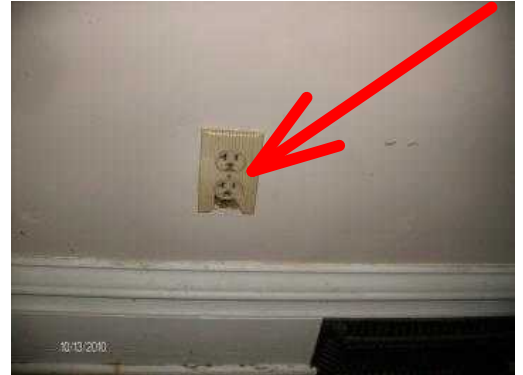
16. ☐ ☒ ☐ ☐ ☐ Electrical: 110 VAC outlets and lighting circuits Cover plates broken.

15. 2nd floor east Bedroom Electrical: 110 VAC outlets and lighting circuits **Cover plates broken.**

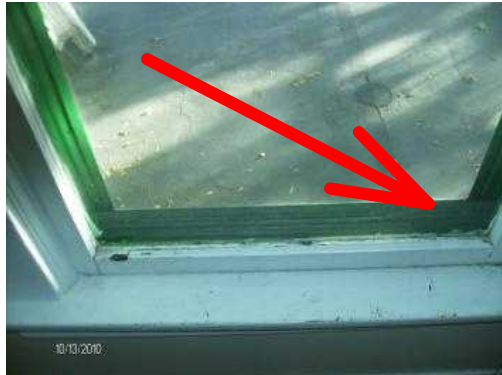
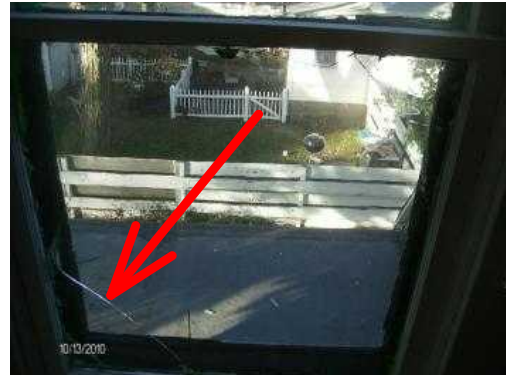
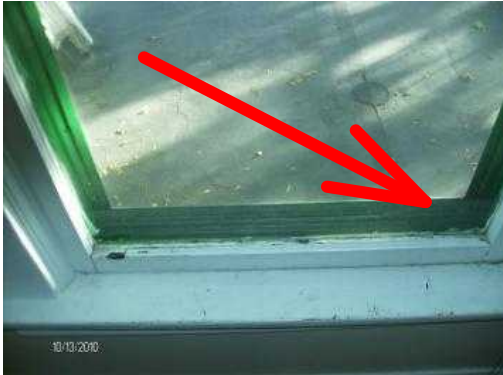
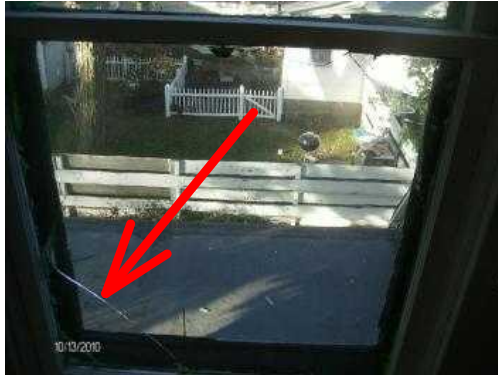
24. ☐ ☒ ☐ ☐ ☐ Windows: Wood double hung **Broken glass**

17. 2nd Floor south Bedroom Windows: Wood double hung **Broken glass**

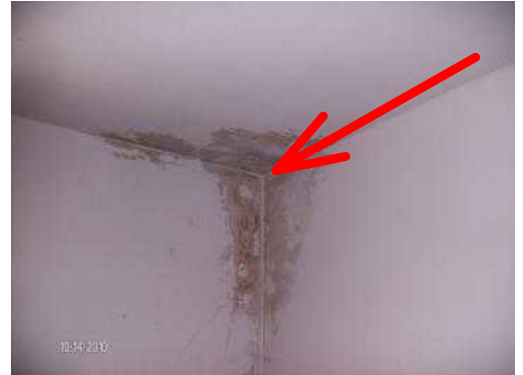
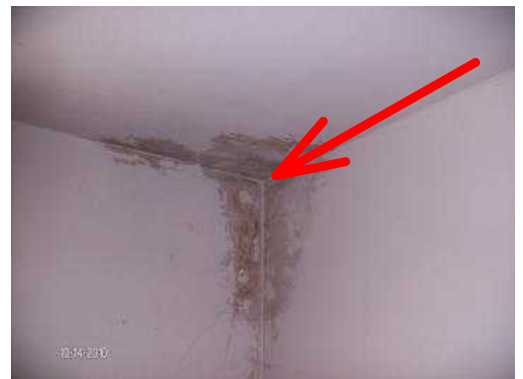
29. ☐ ☒ ☐ ☐ ☐ Ceiling: Paint Cracks present, Loose or peeling paint

19. 1st floor southeast Bedroom Ceiling: Paint **Cracks present, Loose or peeling paint**

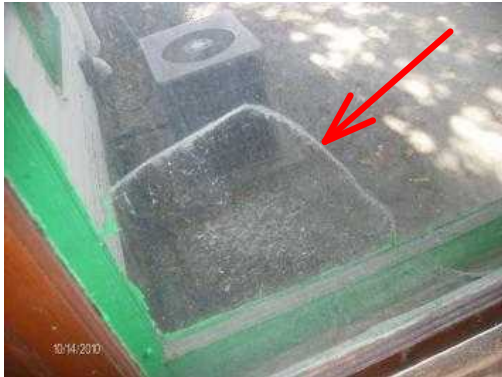
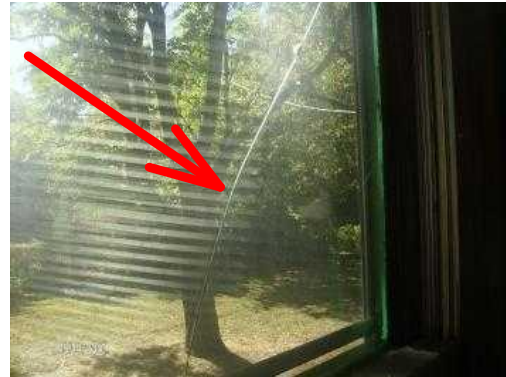
30. ☐ ☒ ☐ ☐ ☐ Walls: Paint Cracks present
 31. ☒ ☐ ☐ ☐ ☐ Floor: Hardwood
 32. ☒ ☐ ☐ ☐ ☐ Doors: Solid wood
 33. ☐ ☒ ☐ ☐ ☐ Windows: Wood double hung Broken glass

21. 1st floor southeast Bedroom Windows: Wood double hung **Broken glass**

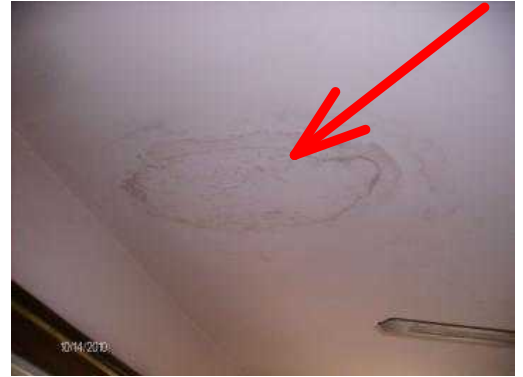
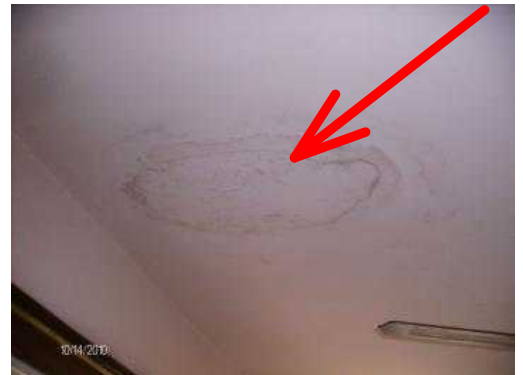
10. ☐ ☐ ☐ ☐ ☒ Ceiling: Paint Evidence of past or present water staining

14. Living Room Living Space Electrical: 110 VAC outlets and lighting circuits Open or missing ground
15. Dining Room Living Space Ceiling: Paint Evidence of past or present water staining

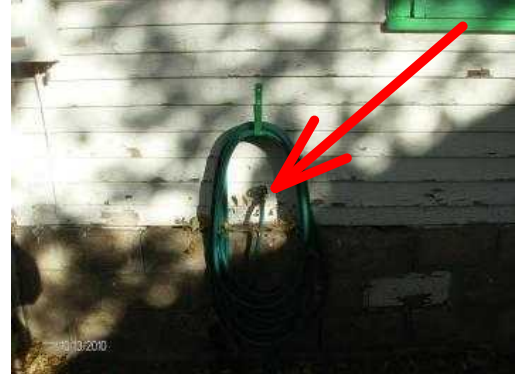
12. ☐ ☒ ☐ ☐ ☐ Hose Bibs: Rotary **Hose isn't freeze proof**

2. Hose Bibs: Rotary Hose isn't freeze proof

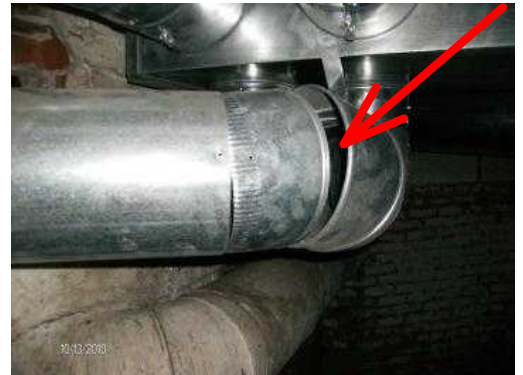
1. ☒ ☐ ☐ ☐ ☐ Heating System Operation: Adequate
2. Manufacturer: Armstrong
3. Model Number: G1D91AU125D20D-1A Serial Number: 841C29513
4. Type: Forced air Capacity: 125,000 BTU
5. Area Served: Whole building Approximate Age: Unknown
6. Fuel Type: Natural gas
7. ☒ ☐ ☐ ☐ ☐ Heat Exchanger: Unable to inspect
8. Unable to Inspect: 50%
9. ☒ ☐ ☐ ☐ ☐ Blower Fan/Filter: Direct drive with disposable filter
10. ☐ ☒ ☐ ☐ ☐ Distribution: Metal duct Duct has pulled apart.

7. Basement Heating System Distribution: Metal duct Duct has pulled apart.
