Home Inspection Report

Somewhere
Nebraska USA

Prepared for: **John Doe**

Prepared by: **Advanced Home Inspections**
540 8th Ave. P.O. Box 146
Fairmont, NE 68354
Phone: 402-266-1373
Email: advancedhi@windstrem.net

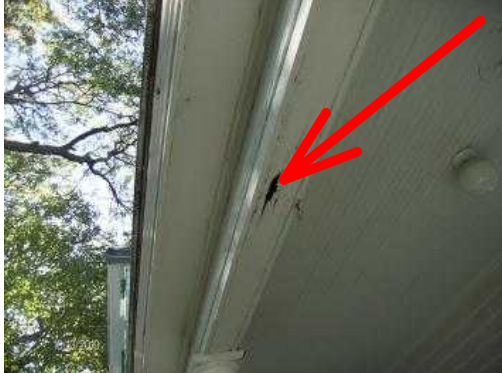
| 4. | <input type="checkbox"/> | <input checked="" type="checkbox"/> | <input type="checkbox"/> | <input type="checkbox"/> | <input type="checkbox"/> | Porch: Wood Rotting wood. Foundation has been damaged. |

1. Porch: Wood Rotting wood. Foundation has been damaged.

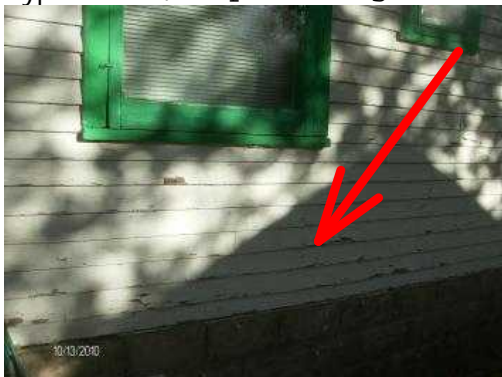
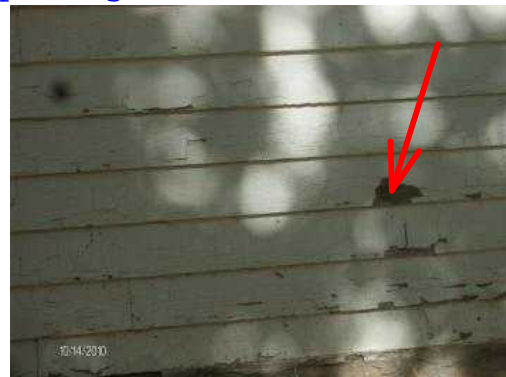
1. ☐ ☐ ☐ ☐ ☒ Type: Wood, lap siding [Paint peeling](#)

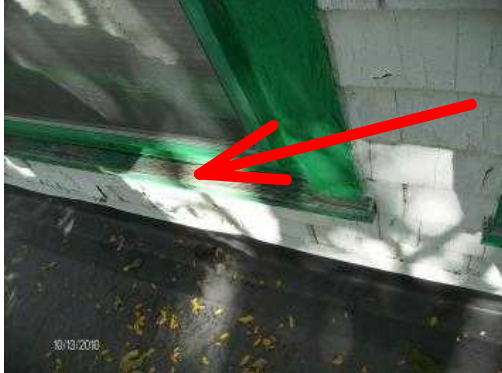
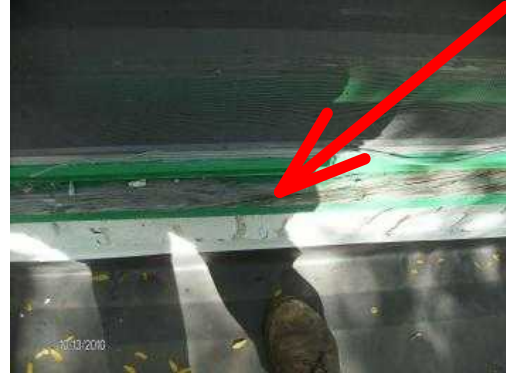
7. ☐ ☐ ☐ ☐ ☒ Windows: Wood double hung **Paint peeling.**

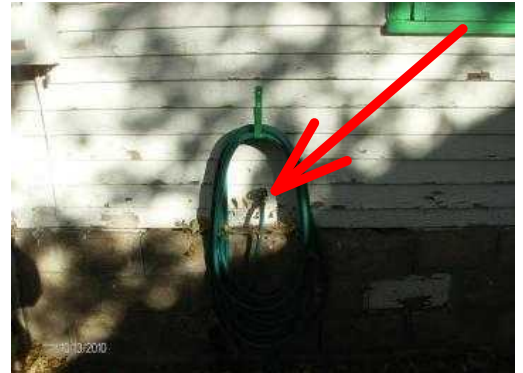
12. ☐ ☒ ☐ ☐ ☐ Hose Bibs: Rotary **Hose isn't freeze proof**

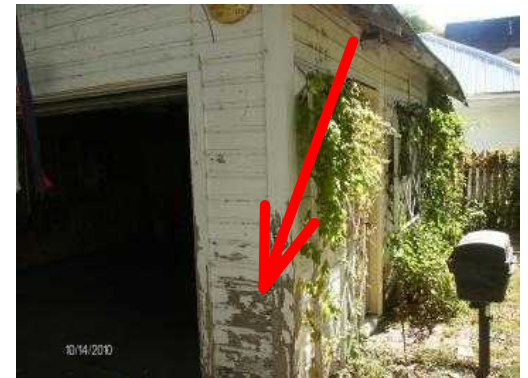
4. ☐ ☐ ☐ ☐ ☒ Exterior Surface: Wood, drop siding **Paint peeling**

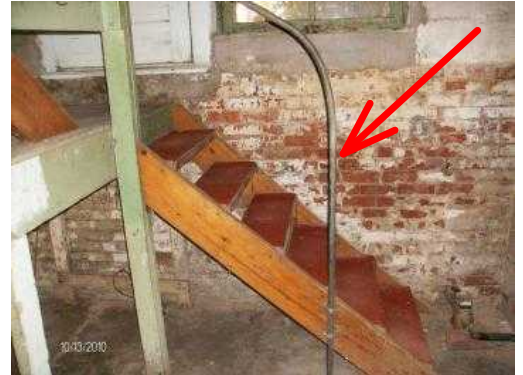
7. ☐ ☐ ☐ ☐ ☒ Stairs/Handrails: Wood stairs with metal handrails Hand rail isn't adequate.

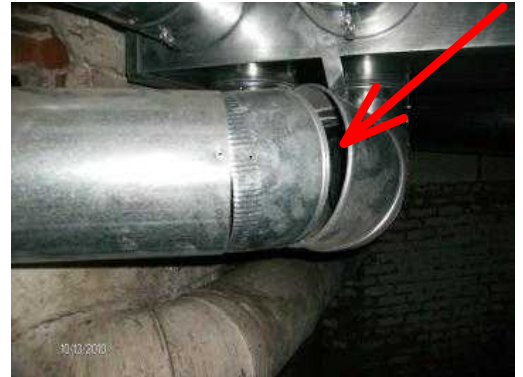
1. ☒ ☐ ☐ ☐ ☐ Heating System Operation: Adequate
2. Manufacturer: Armstrong
3. Model Number: G1D91AU125D20D-1A Serial Number: 841C29513
4. Type: Forced air Capacity: 125,000 BTU
5. Area Served: Whole building Approximate Age: Unknown
6. Fuel Type: Natural gas
7. ☒ ☐ ☐ ☐ ☐ Heat Exchanger: Unable to inspect
8. Unable to Inspect: 50%
9. ☒ ☐ ☐ ☐ ☐ Blower Fan/Filter: Direct drive with disposable filter
10. ☐ ☒ ☐ ☐ ☐ Distribution: Metal duct Duct has pulled apart.

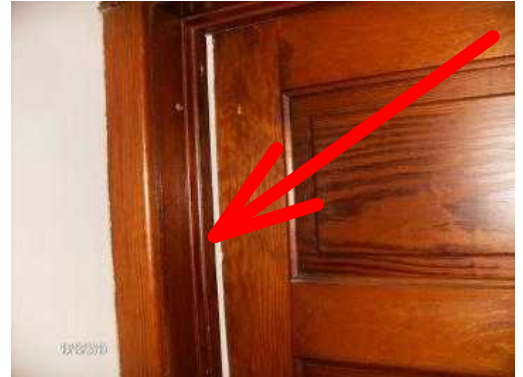
5. ☐ ☐ ☐ ☐ ☒ Doors: Solid wood Door will not close.

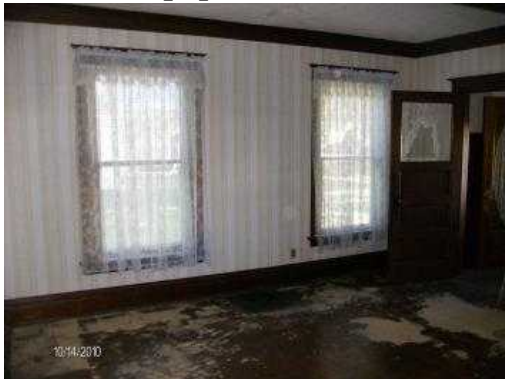
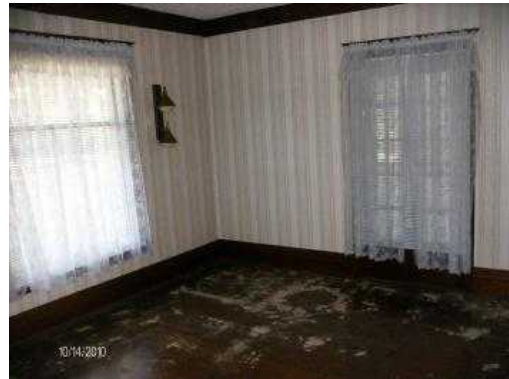
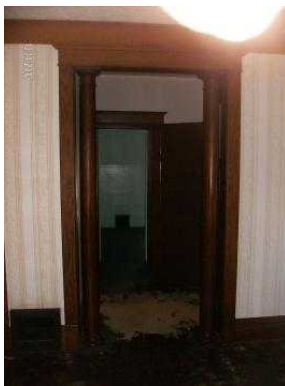
4. ☒ ☐ ☐ ☐ ☐ Floor: Hardwood
5. ☒ ☐ ☐ ☐ ☐ Doors: Solid wood
6. ☒ ☐ ☐ ☐ ☐ Windows: Wood double hung, Non-opening
7. ☐ ☐ ☐ ☐ ☒ Electrical: 110 VAC outlets and lighting circuits Open or missing ground
8. ☒ ☐ ☐ ☐ ☐ HVAC Source: Heating system register
9. ☐ ☐ ☒ ☐ ☐ Smoke Detector:

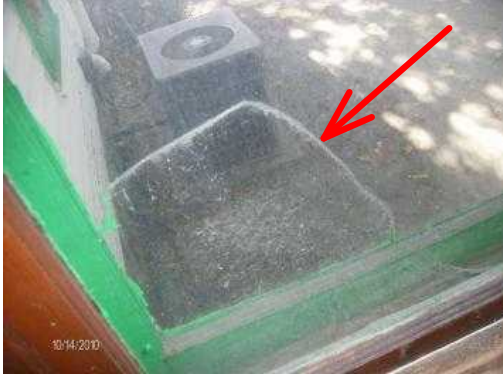
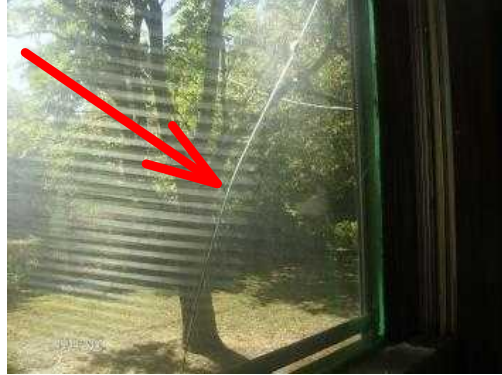
21. 1st floor southeast Bedroom Windows: Wood double hung **Broken glass**

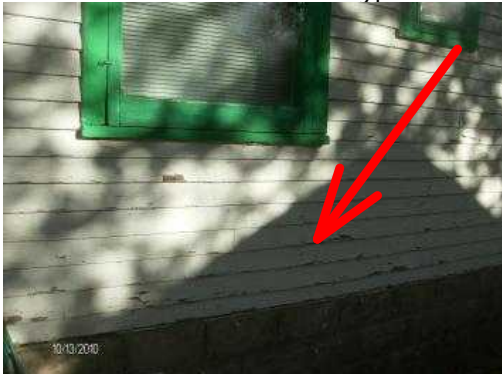
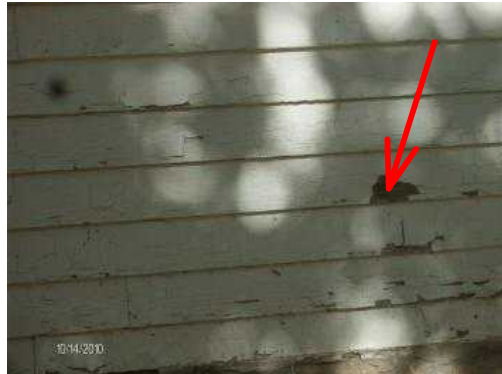
2. All sides. Exterior Surface Type: Wood, lap siding Paint peeling

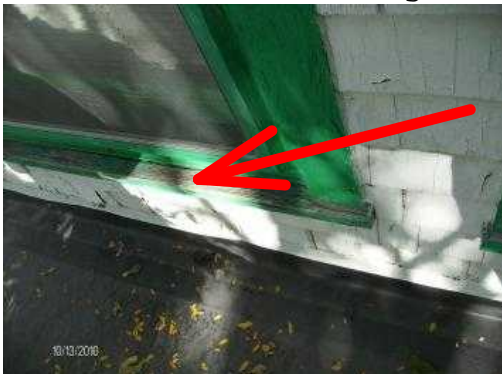
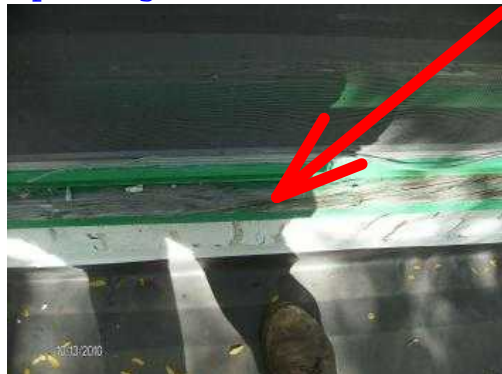
3. Windows: Wood double hung Paint peeling.

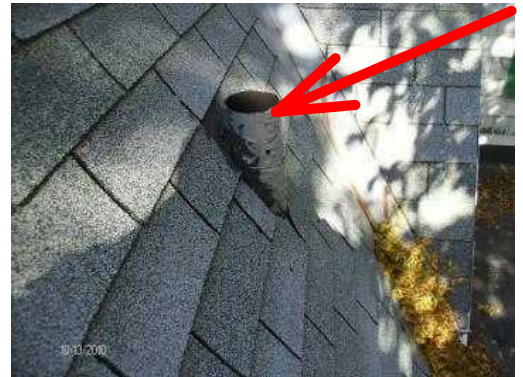
5. Plumbing Vents: Cast Iron Vents do not extend above roof enough.

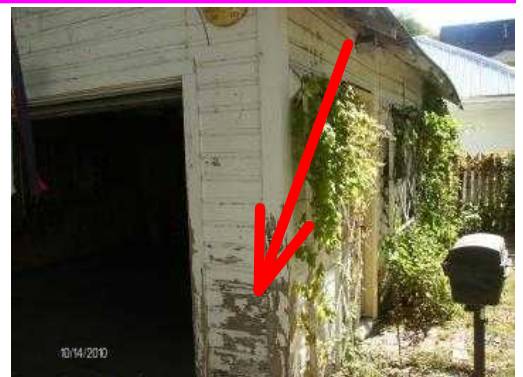
6. Detached Garage Exterior Surface: Wood, drop siding Paint peeling

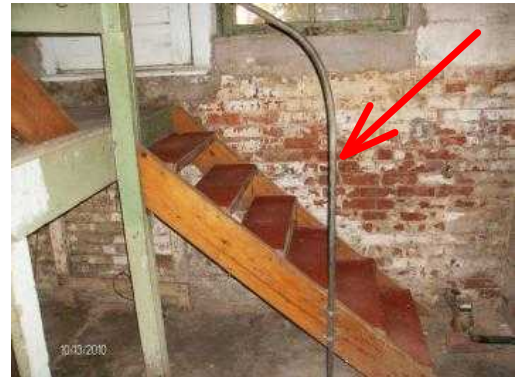
8. Stairs/Handrails: Wood stairs with metal handrails Hand rail isn't adequate.

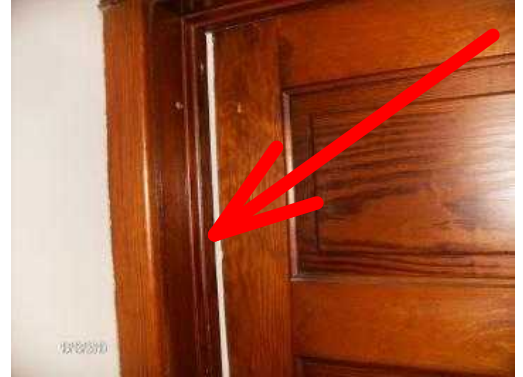
12. 2nd floor north Bedroom Doors: Solid wood Door will not close.
